Safety Inspection Report

Annual Inspection

Church Street

Worthington Parish Council

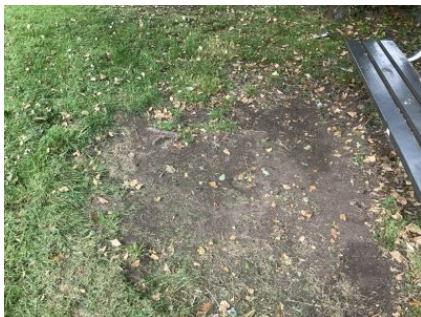
Worn ground areas.

Worn areas exposing tree roots and creating trip points.

Build up ground levels to remove trip hazard.

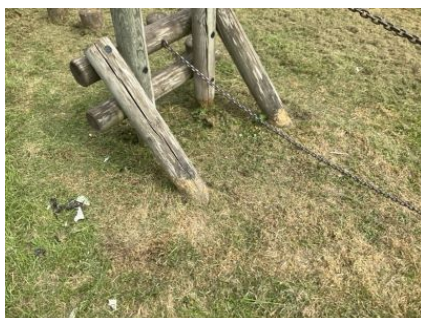
Strimmer damage is present on posts, allowing water to enter and timbers to soften. It can also remove the protective envelope around the timber. Prevent further damage and check timbers for decay throughout the year.

Prevent further damage.

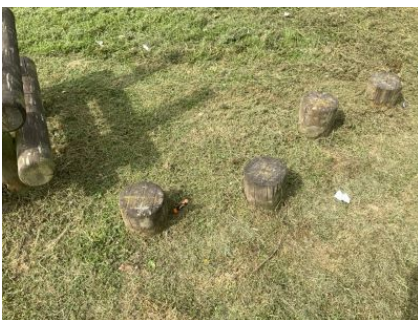
Timber is decayed.

There is some softening of the timber stepping logs at ground level. Monitor for any further deterioration and replace stepping pods as required.

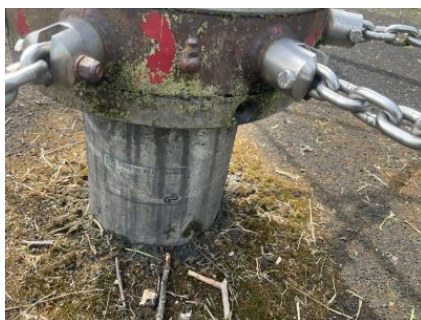
Fixtures loose or missing.

Fixings x 2 missing from bottom bearing housing.

Replace.

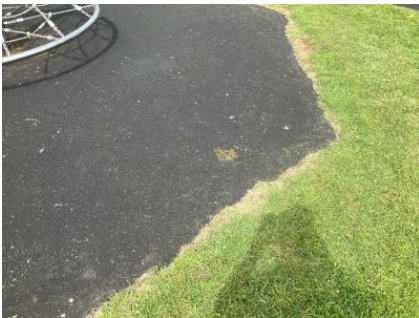
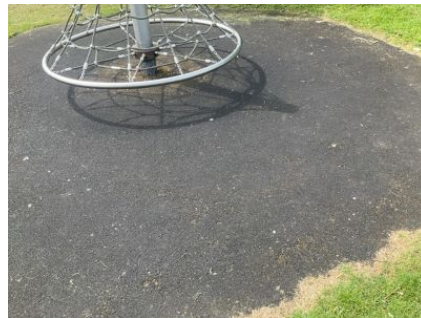
Surface is wearing.

Monitor for significant deterioration and rectify when necessary.

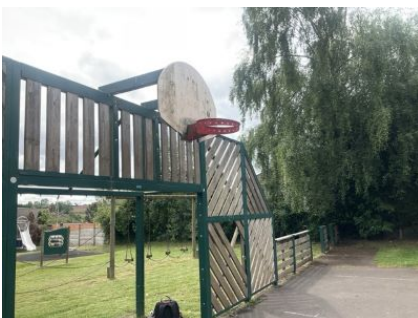
A clearly visible sign must be fitted to all sports related equipment with at least the following: a) equipment is not intended for children less than 36 month, b) "Do not climb on the framework or nets", c) "Do not hang on the ring", d) "Do not wear rings or other jewellery as these can get caught and cause injury", e) name and telephone number of site owner, f) number to call in case of accident.

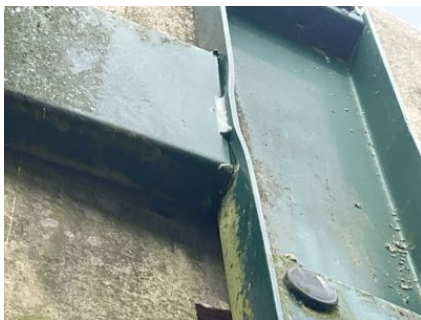
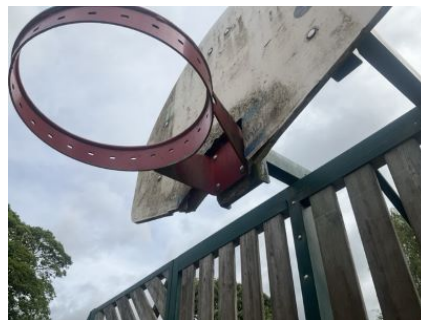
Welds are cracked.

Backboard frame, weld cracked and board is damaged. Replace board and repair frame.

Repair.

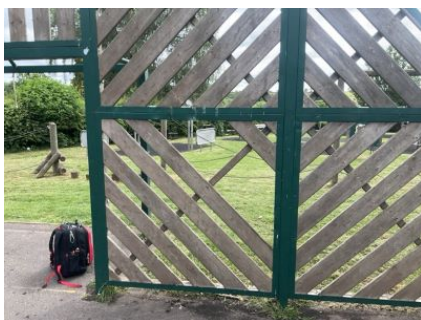
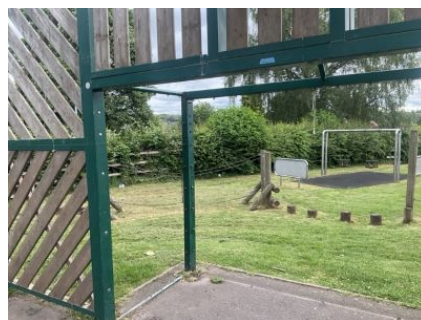
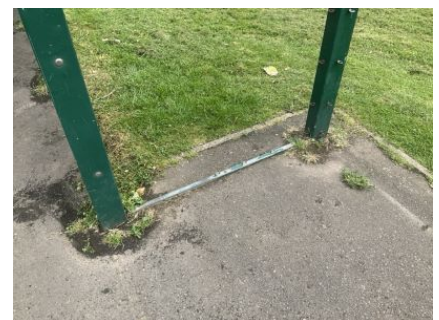
Item has some parts missing.

Goal net and slats missing. Ball can pass through goal and hit users of other items of play. The net bar is also creating potential trip points.

Replace the missing parts.

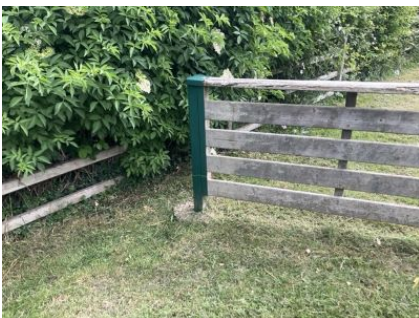
Loose in ground.

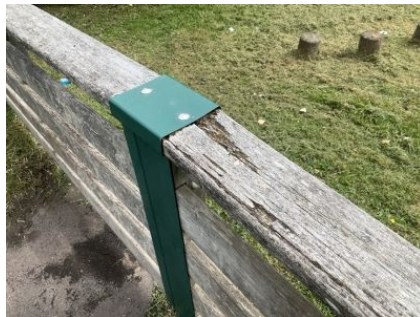
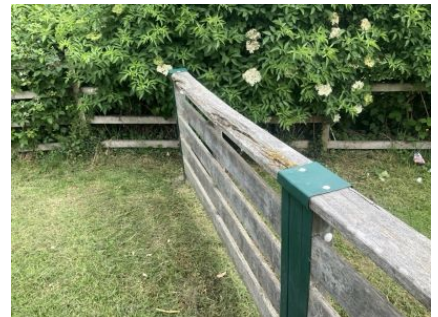
Timber is decayed.

Sand back rough edges and monitor for any further deterioration.

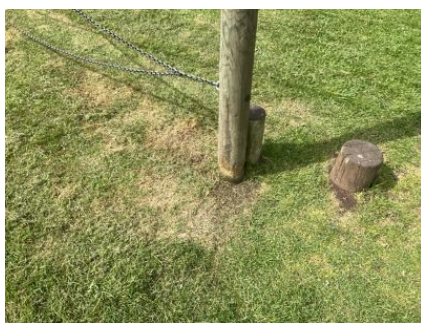
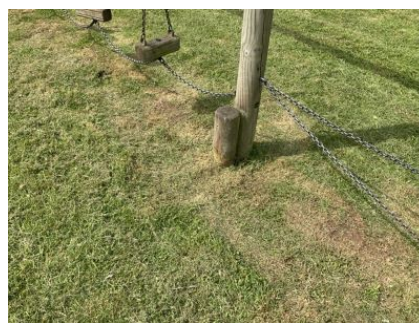
Strimmer damage is present on posts, allowing water to enter and timbers to soften. It can also remove the protective envelope around the timber. Prevent further damage and check timbers for decay throughout the year.

Throughout the trail.

Prevent further damage.

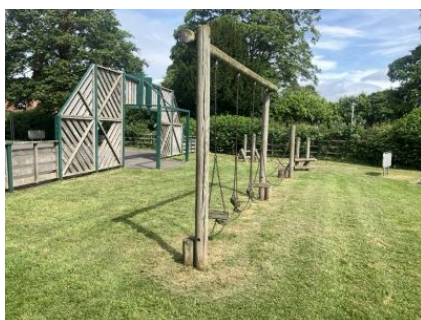
This equipment relies on one post for its stability. Special attention should be paid to maintenance (e.g. by monitoring degradation) and if necessary decommissioning the item before the end of its operating life. This is a requirement of the British Standard.

Consult with the manufacturer's guidance to determine suitable maintenance.

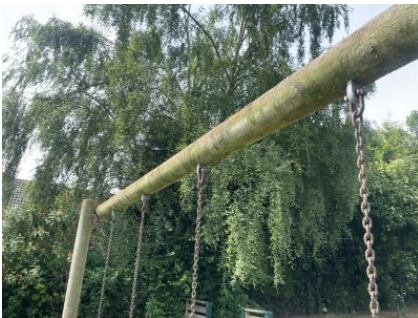
Fittings are rusty.

Replace.

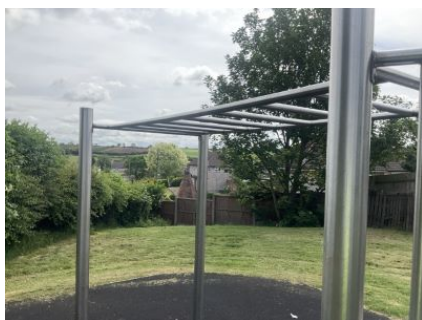
Overhead ladders and rings provide significant play value and benefits to children, and with it the risk of falling. Ensuring the surface remains in good condition will help to keep the correct balance between benefits and risk.

The protective surface under all bars and rings must be kept in good condition.

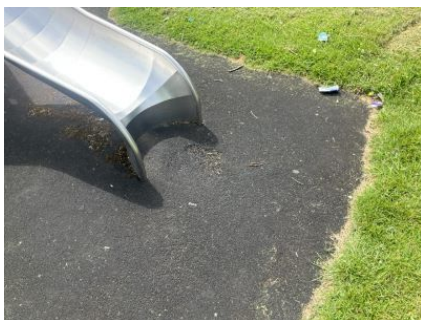
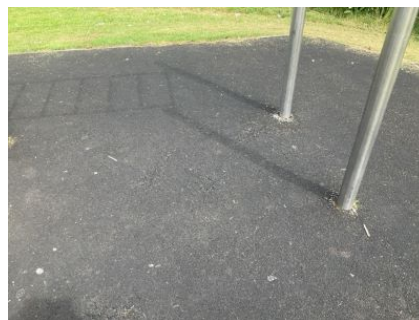
Surface is wearing.

Monitor for any further deterioration and repair when necessary.

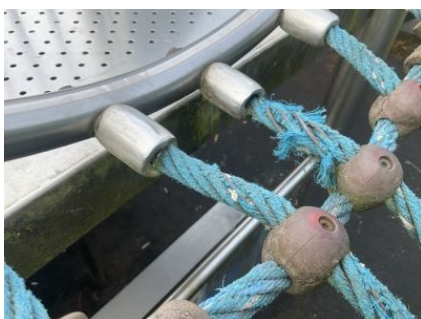
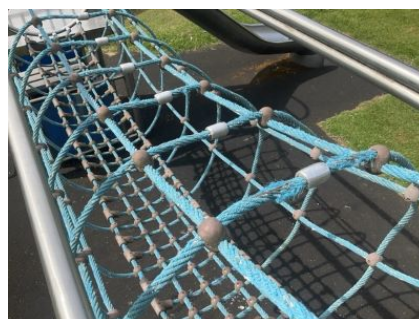
Ropes wearing throughout. Monitor for any sharp or split wire strands and program in replacement/repair.

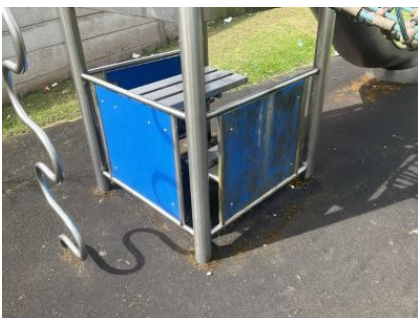
Item has some parts missing.

Replace the missing parts.

Replace missing net or provide a barrier and blank off fixing holes in the platform.

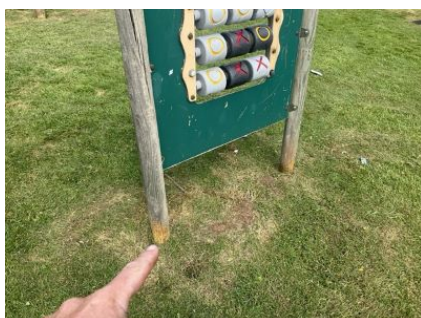
Timber is decayed.

Post x 1 rotten through at ground level and is now loose in the ground. Remove board until replacement post is available.

Replace affected parts.

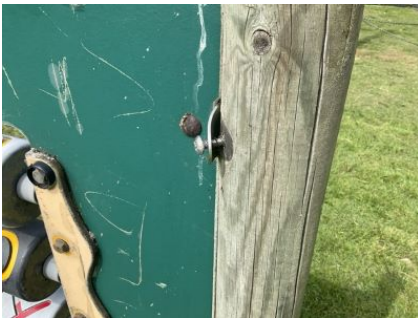
Fixtures loose or missing.

Tighten., Replace.

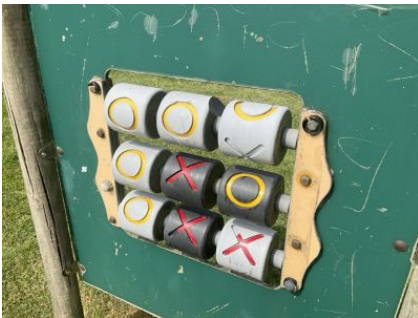
Cap missing.

Replace.

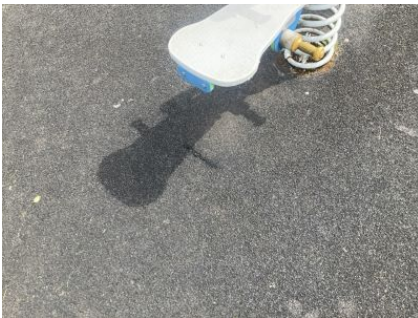
Surface is wearing.

Monitor for significant deterioration and rectify when necessary.

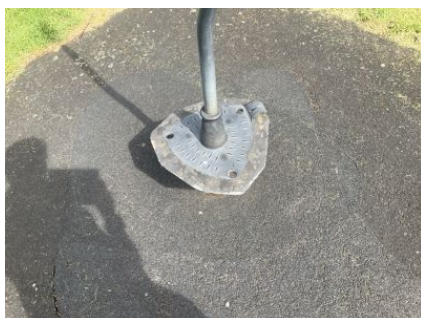
Item is damaged.

Rubber platform damaged, exposing metal edges. Replace platform.

Replace.

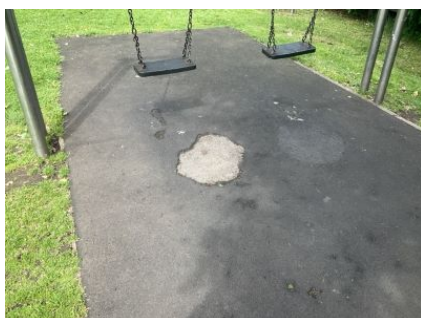
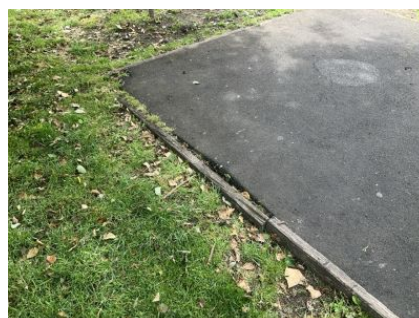
Surface needs repair.

Cracks, holes exposing concrete base, timber edging rotting and sub-base collapsed.

Repair.

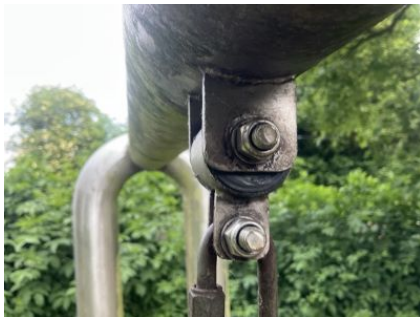
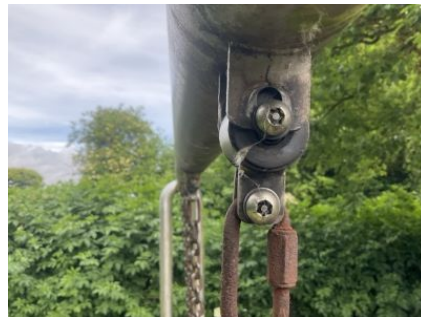
There is wear in the bushes.

Bushes and hanger lugs wearing.

Remove shackle bolt and check bush and shackle pin wear, replacing as necessary.

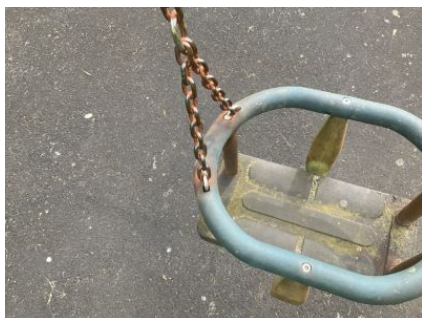
Corrosion in cradle seat top frame could lead to sudden failure of the seat.

Investigate and replace as necessary.

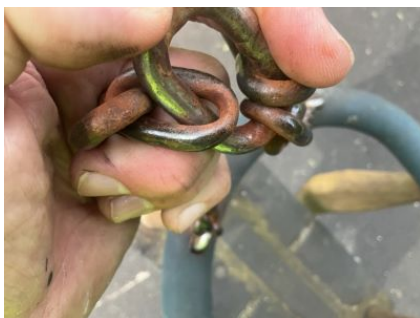
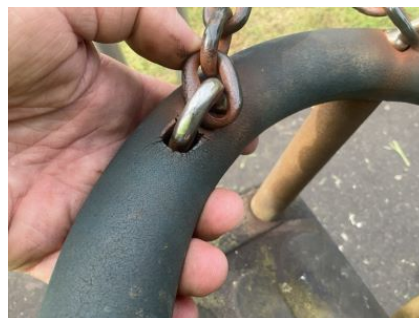
Some chain wear.

Seat links 40% worn. Replace.

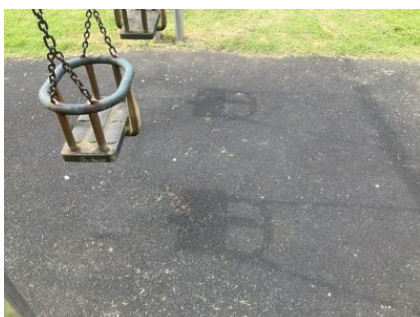
Surface is wearing.

The surface is wearing and starting to crack in places. Monitor for any further deterioration and repair as necessary.
