Safety Inspection Report

Annual Inspection

Church Street

Worthington Parish Council

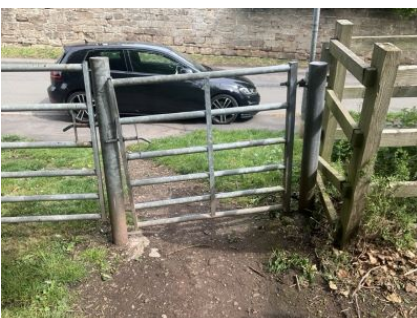
Gate

Item is damaged.

Repair.

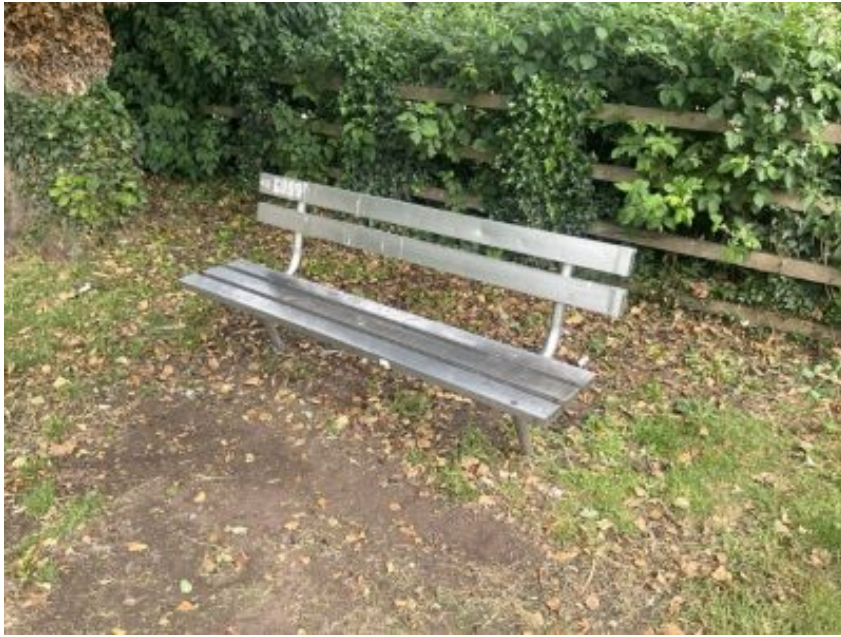
Seating

Worn ground areas.

Worn areas exposing tree roots and creating trip points.

Build up ground levels to remove trip hazard.

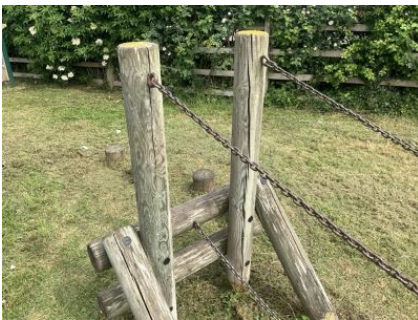
Bridge & Step Logs

Strimmer damage is present on posts, allowing water to enter and timbers to soften. It can also remove the protective envelope around the timber. Prevent further damage and check timbers for decay throughout the year.

Prevent further damage.

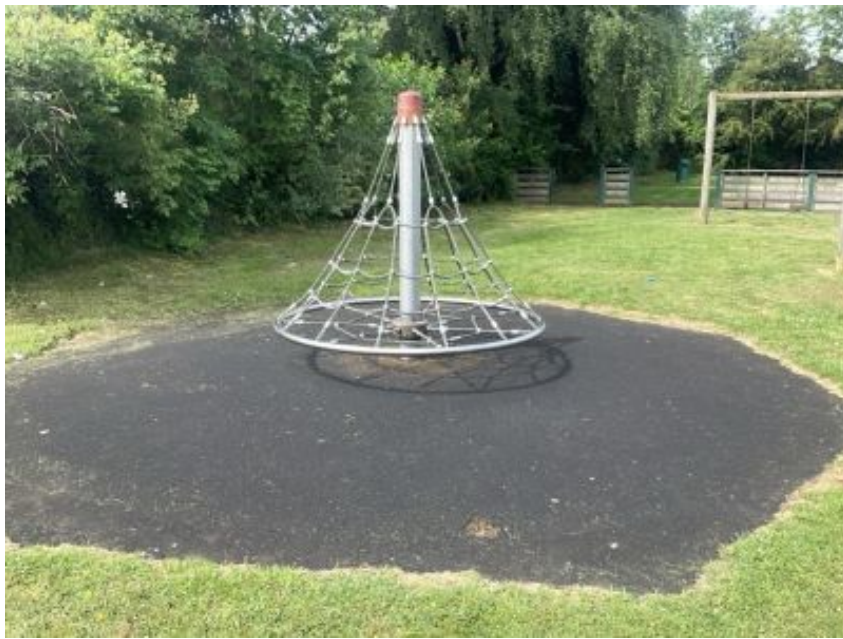
Climber - Rota Web

Fixtures loose or missing.

Fixings x 2 missing from bottom bearing housing.

Replace.

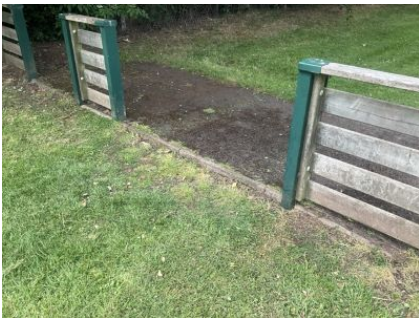
Loose in ground.

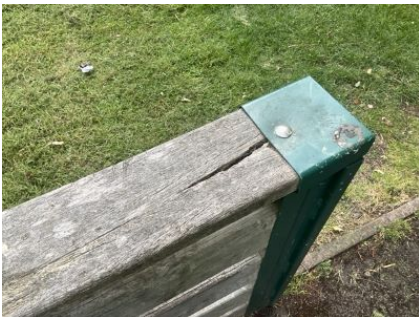
Timber is decayed.

Sand back rough edges and monitor for any further deterioration.

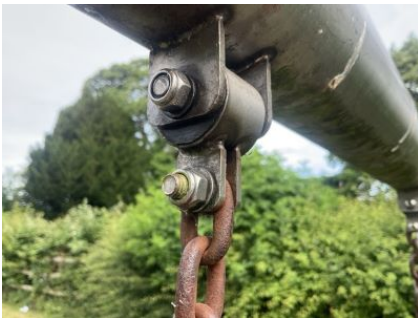
Fixtures loose or missing.

Swing hanger fixing x 1 loose. Secure.

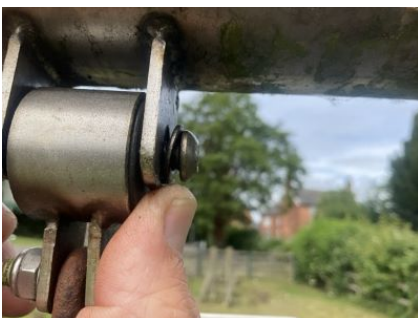
Some chain wear.

Seat links 40% worn. Replace.
